Division of Waste Management Solid Waste Section

Waste Management of Raleigh-Durham Transfer Station 10411 Globe Road Morrisville, NC 27560

Comprehensive Inspection

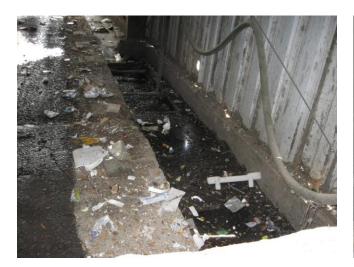
- 11. There were 2 fire extinguishers on walls beside the tipping floor, 1 extinguisher behind the push wall, and 1 extinguisher in the trailer tunnel. All extinguishers were properly charged and inspected.
- 12. Leachate is collected in a 3000-gallon above ground tank. The liquid is hauled as needed by a contractor.
- 13. The grate covering the leachate collection sump adjacent to the loading bay was missing at the time of the inspection. I would recommend replacing the grate in order to reduce the maintenance required to keep waste from the loading bay out of the sump. These materials may also cause malfunction of the sump pump over time. Additionally, the open sump could pose a safety concern for workers.

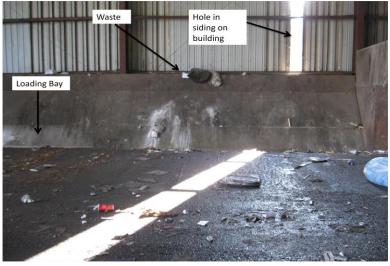
- 14. Ensure that the drain on the outside of the loading bay is cleaned out frequently and well maintained. A small amount waste is evident in the stormwater basin below the drainage outfall.
- 15. The area behind the push wall is in need of cleaning. The area adjacent to the door was being well maintained but the less accessible area behind the wall is in need of attention. Corrective actions are needed within 30 days of receipt of this inspection.
- 16. The perimeter walls of the transfer station need to be maintained in a clean, sanitary condition. Waste that has perched above the loading bay must be removed at the end of every day.

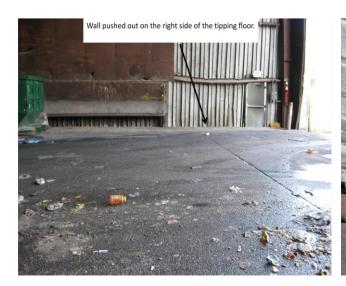
17. There is a gap between the wall and tipping floor on the right side of the transfer station building. Positive drainage is away from this side of the building but care is needed during cleaning of the tipping floor to ensure that leachate does not leak out from the gap.
